# PARACHUTES AUSTRALIA

## SERVICE BULLETIN No PA SB0901

**SUBJECT:** 3-RING RISER INSPECTION

**IDENTIFICATION:** All 3-ring risers manufactured by Parachutes Australia

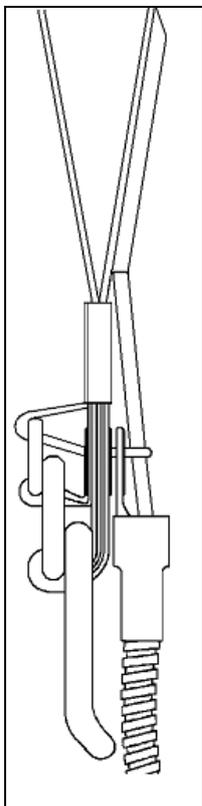
While 3-ring risers may be constructed of different materials the following points define the proper criteria for a correctly built 3-ring riser when attached to the harness ring and put under moderate tension.

- The rings should overlap each other and maintain metal to metal contact between each other.
- The rings should be aligned in parallel planes.
- The smallest ring should not be pulled snug against the grommet by the locking loop which should be long enough to give it some play.
- The locking loop should go straight through the riser grommet on its way to the cable housing end fitting.
- It should be checked that NO suspended load is supported by the cable housing and locking loop due to the cable housing being incorrectly positioned in the harness or being too short.

PA manufactured 3- ring risers **not** meeting the requirements of APF Service Bulletin APF010801-C must be sent to PA for correction and return at no charge.

The owners of PA manufactured 3- ring risers that have locking loops shorter than that as detailed in the above mentioned Safety Notice but **do** meet the requirements of APF Service Bulletin APF010801-C that feel uncomfortable about the length of the locking loops can also send them to PA for lengthening and be returned at no charge.
